# Conserving War Memorials

## Case Study: Deterioration of Metal Fixings

Waterloo War Memorial, Bispham Hall, Wigan,  
Greater Manchester

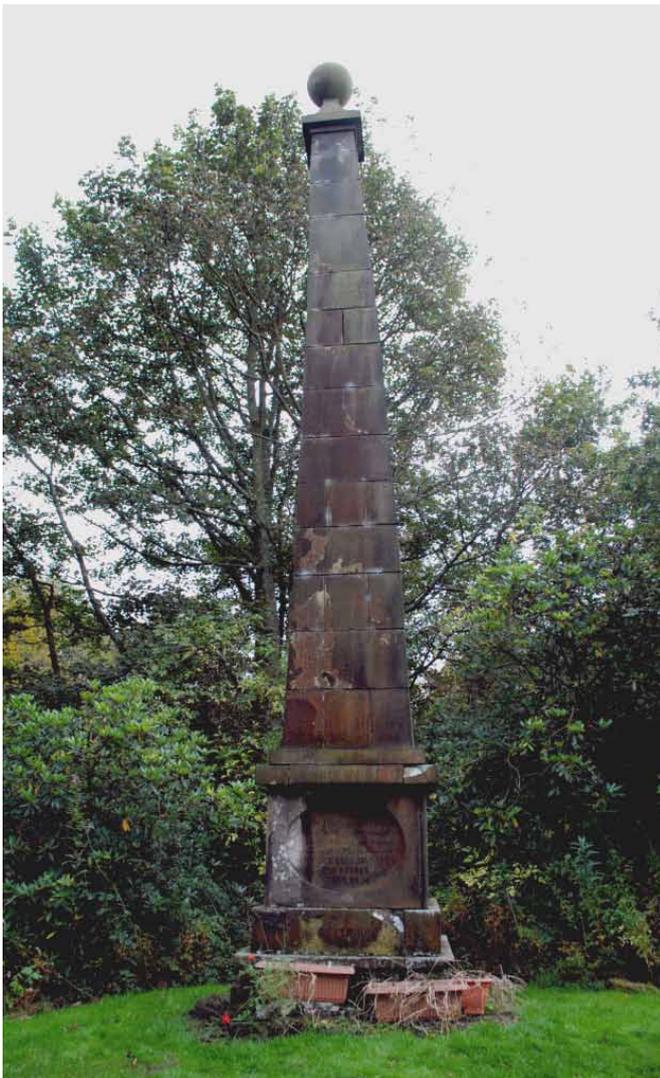
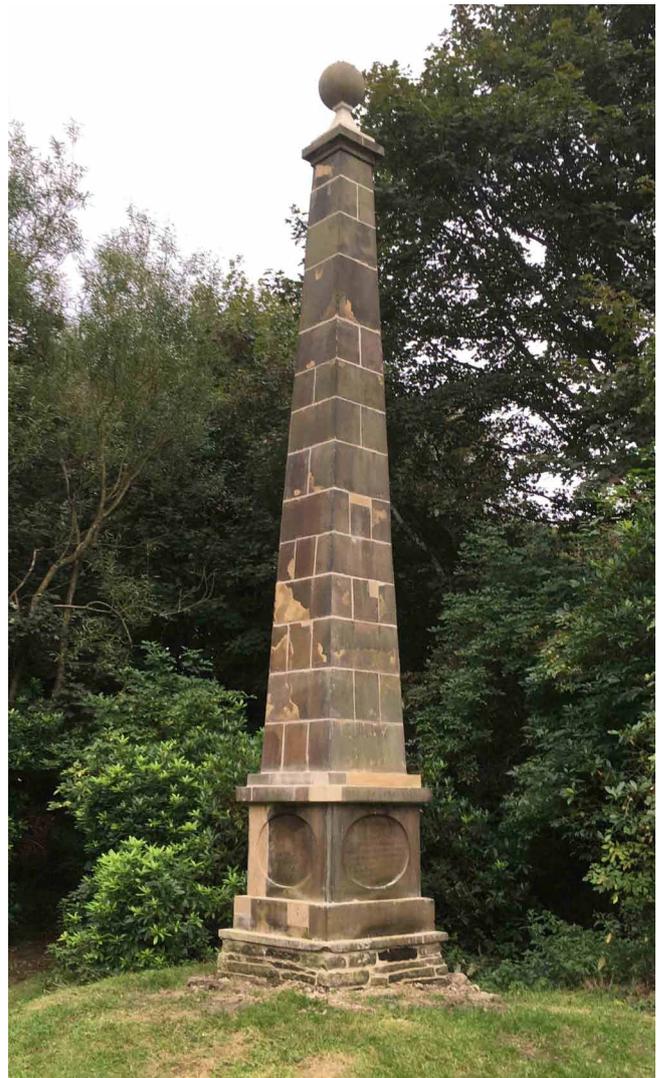
Bispham Waterloo war memorial before and after conservation work. ©Jubb and Jubb Ltd.

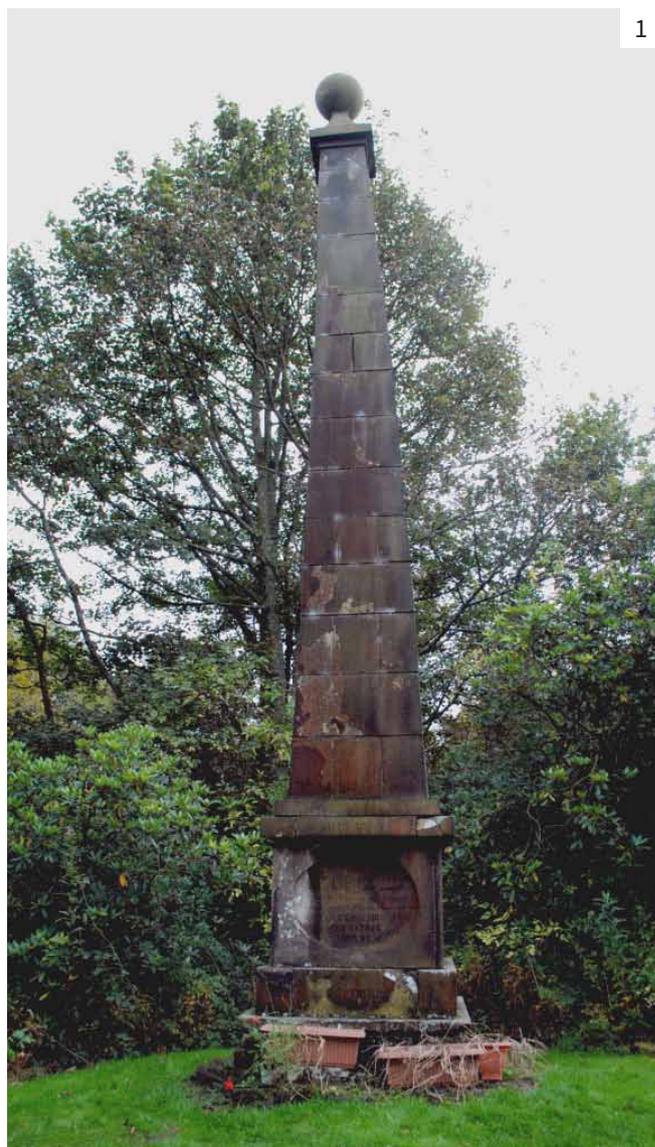
The custodian was concerned because the monument appeared to be leaning over: the deformation was clearly visible in the top two-thirds of the obelisk. Previous investigations had suggested that an iron rod was embedded within the centre of the obelisk, fixing the ball finial in place, but this was unconfirmed.

- 1 The sandstone monument consists of an obelisk, capped with a ball finial on an inscribed stone plinth. The deformation to the top third of the monument is evident.

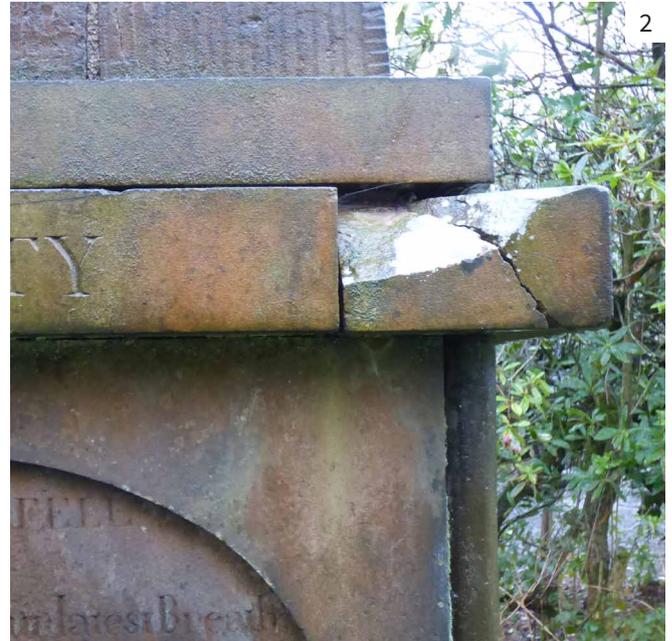
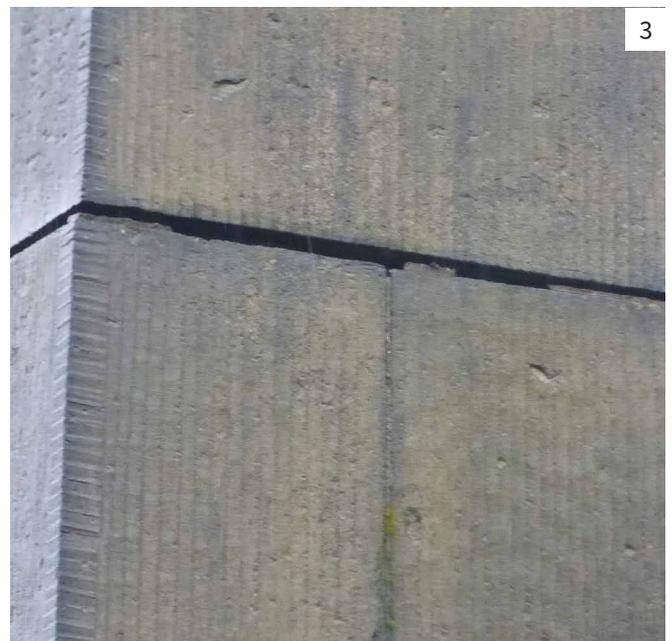
However, what was apparent from visual inspection was that the wrought-iron cramps used to secure the stones had corroded, causing cracks in the masonry. The cramps had also jacked the course joints open, causing distortion throughout, which threatened the stability of the whole monument.

Therefore, the corroding cramps embedded within the structure were identified as the source of the deformation and damage to the stone.

- 
- 2 Cracking and spalling of plinth stonework caused by corroding cramps.
  - 3 Open joints where movement had caused the loss of mortar.

Another option was dismantle the memorial, remove the corroded cramps, and rebuild it using new stainless-steel cramps.

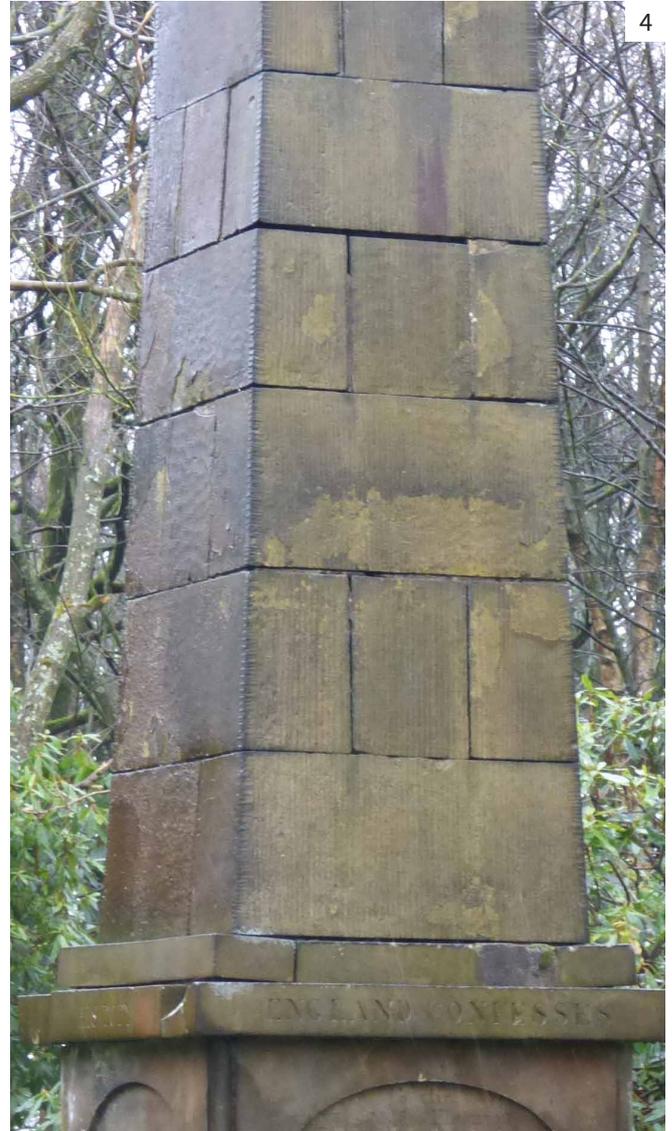
- 4 The effect of corroded cramps was evident in the jacking of course joints throughout the monument. Individual masonry pieces were generally in a sound condition, with minor surface delamination.

The preferred option to address the underlying issue and secure the long-term conservation of the monument was to dismantle it, remove the corroded cramps, and rebuild it with new ones. Underpinning was not required as most of the deformation occurred above plinth level. Small variations in the level at the top of the plinth caused by settlement (less than 10mm over 1000mm) were capable of correction by levelling the courses.

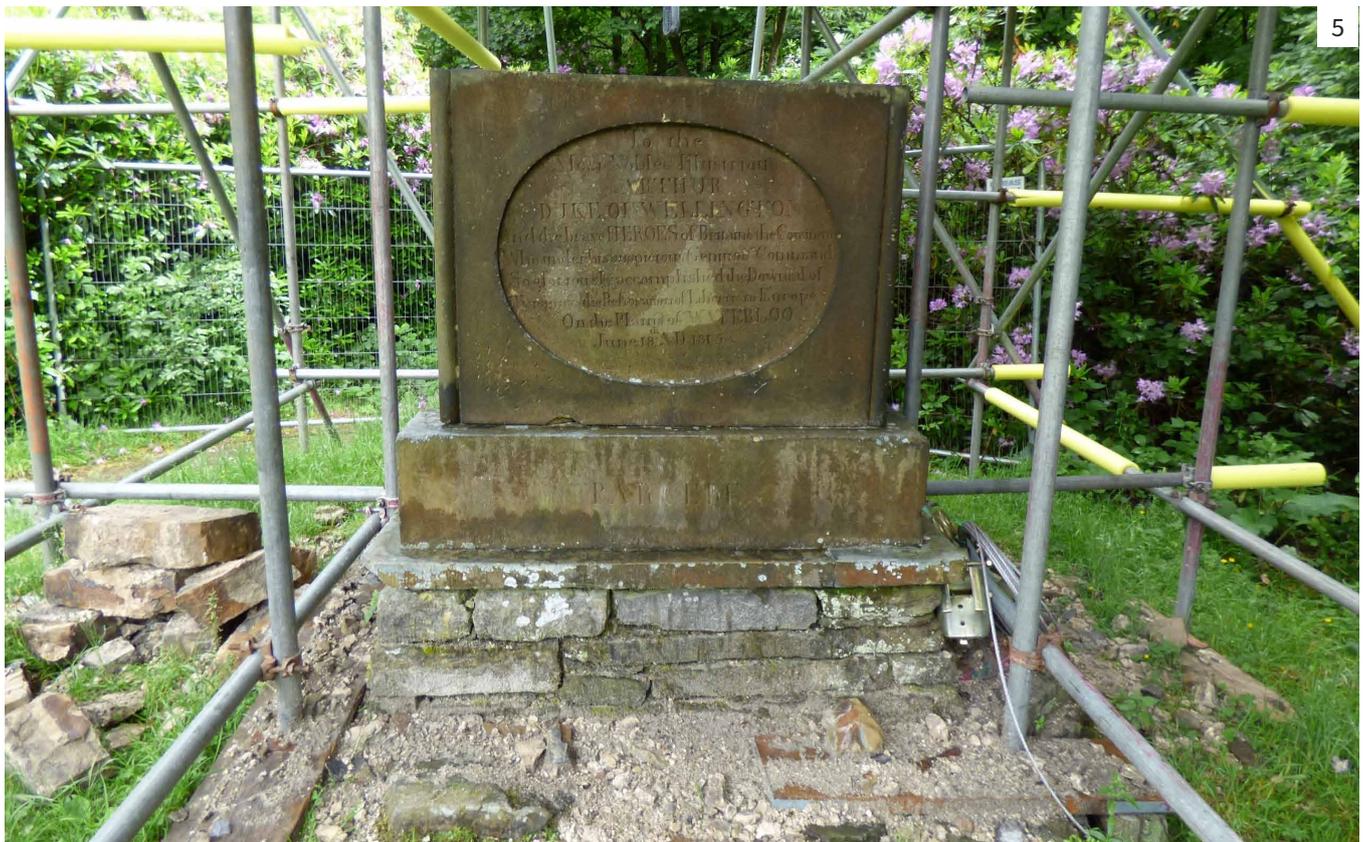
5 The monument was dismantled down to the plinth, which sits on a coursed stone base.

It was decided to take the monument down to plinth level in order to access and inspect all of the ferrous cramps to ensure that if any could be left *in situ*, they would not corrode enough to start the cycle again.

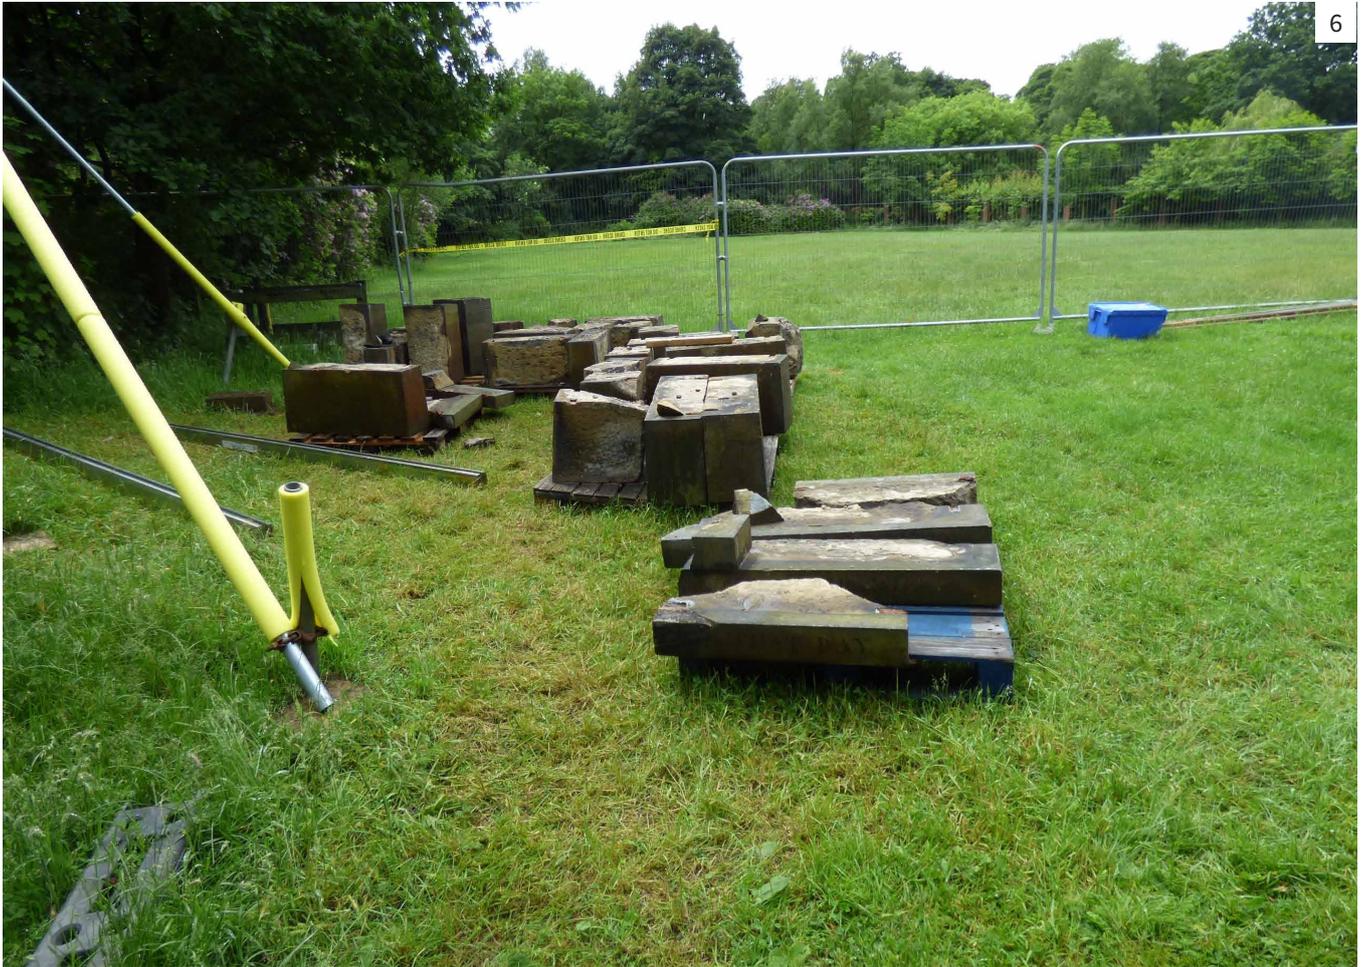
- 6 As dismantling continued, the masonry elements were carefully stored so that they could be incorporated accurately as the monument was rebuilt.

A detailed photographic record of the monument and index of the location and orientation of each stone was kept. The monument was then carefully dismantled. Old mortar was scraped off the stones and they were set aside for re-use.

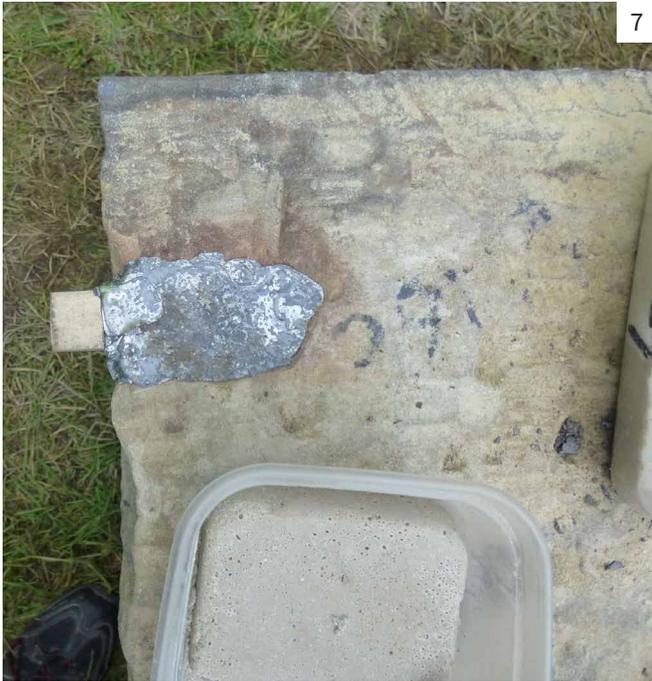
- 7 Replacement stainless-steel cramps were fixed in lead. This image shows a trial after the lead was introduced. Hot, molten lead was poured into the cavity in the stone. Once cooled, the lead solidifies tightly around the cramp (not seen).

The corroded cramps were replaced with austenitic stainless-steel cramps (grade 316), set with poured lead. Other options were considered to set the cramps – including the cost-saving option of a resin compound – but the more authentic repair using poured-lead fixings was preferred. Working with the poured lead also provided an opportunity for the development craft skills. A detailed method statement was prepared by the contractor, along with samples on an off-cut of stone to check the quality of this method before it was used on the monument.
